Wasp Inspection Cover

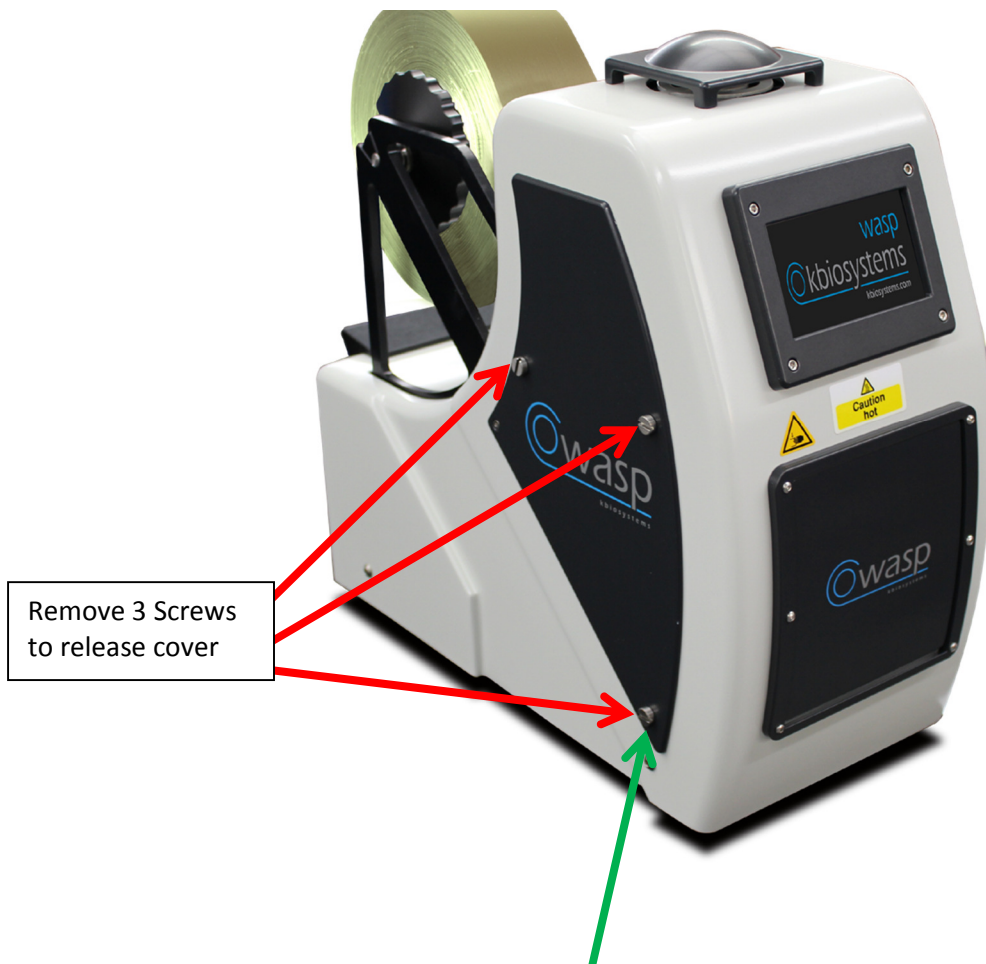
Remove the three screws attaching the Left side inspection Cover.

Replace Lower screw to enable operation of Wasp.

Heater block can be at HIGH TEMPERATURES DO NOT TOUCH by hand
